LAGUNA SHORES ROAD IN CORPUS CHRISTI, TX RESILIENCE DURABILITY TO EXTREME WEATHER PILOT PROJECT

REPORT JUNE 8, 2021

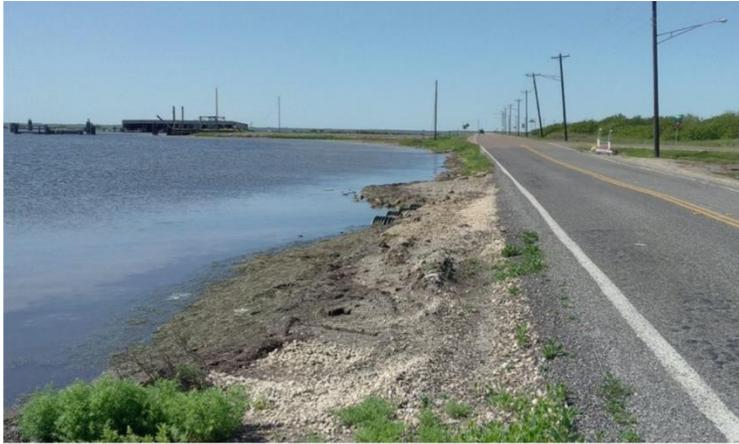
Exhibit 4. Images of Pilot Project Initial Condition

Looking south at the project location on Laguna Shores Road under typical (non-storm) conditions. Photo credit: Corpus Christi MPO.

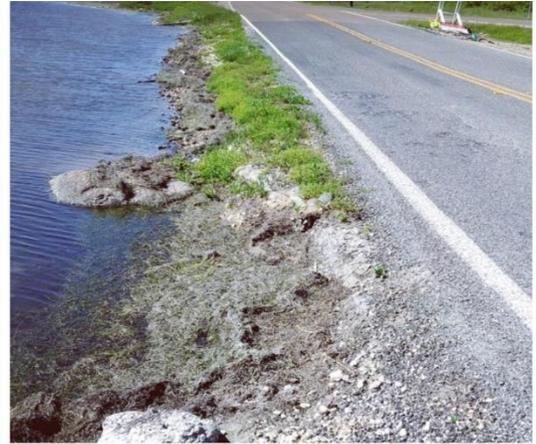
Close-up, note the irregular edge of pavement and proximity to open water. Photo credit: Corpus Christi MPO.

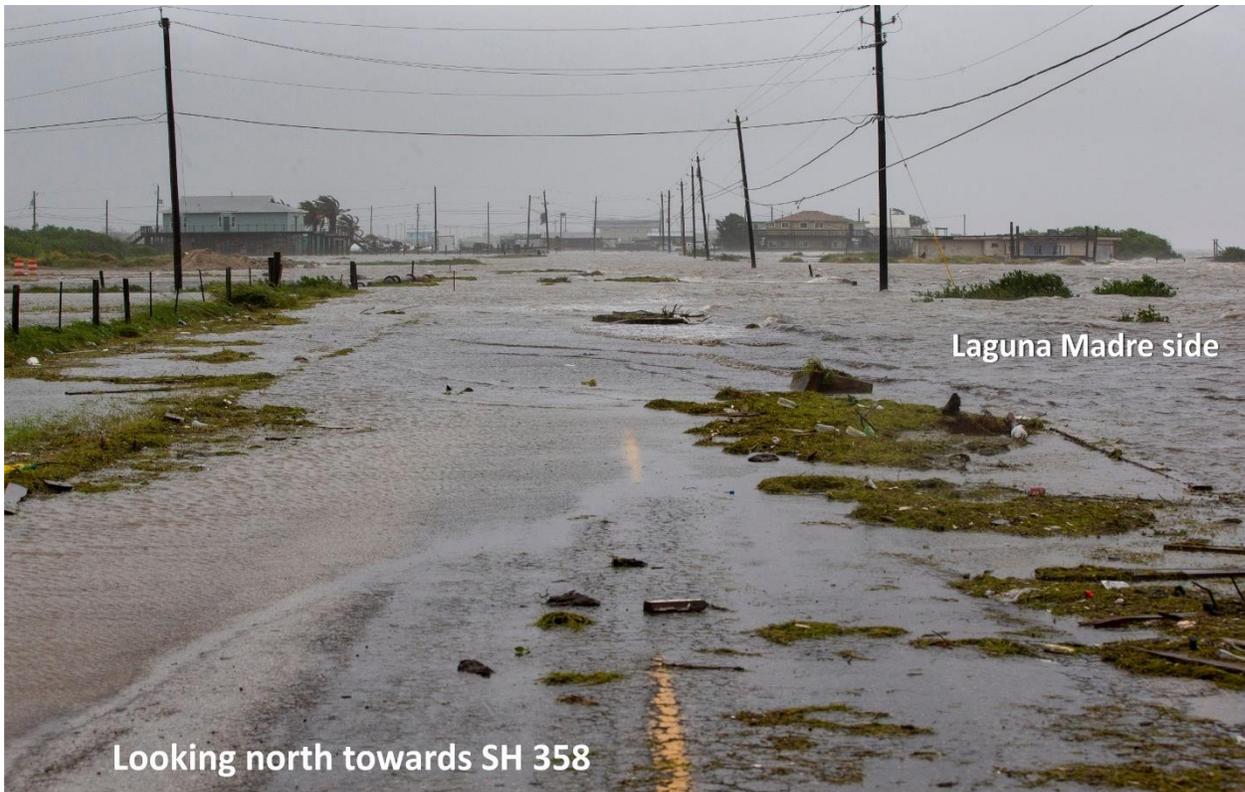
Exhibit 5. Image of Pilot Project Initial Problem

Water spill over Laguna Shores Road after Hurricane Hanna made landfall south of Corpus Christi on Padre Island at 5 p.m., July 25, 2020. A Category 2 storm Hanna made a second landfall at 6:15 p.m. in Kennedy County, south of Corpus Christi. Photo credit: Corpus Christi Caller-Times. Photographer Courtney Sacco. Used by permission.

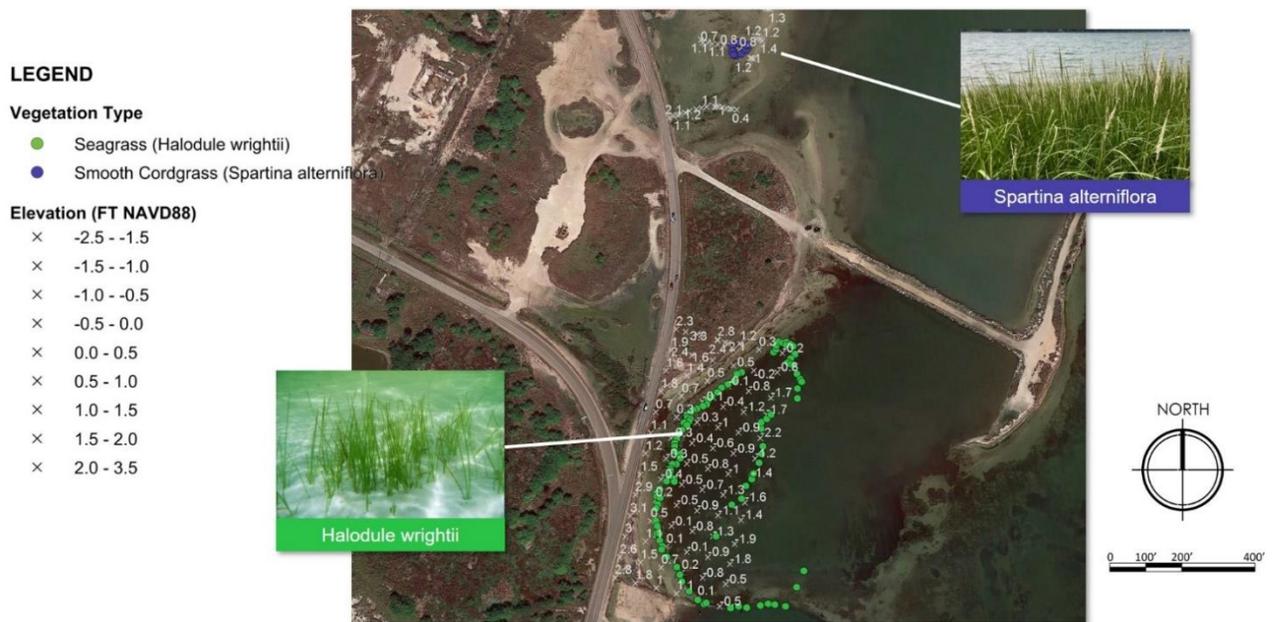
Exhibit 7. Aerial of Data Collection Locations for Condition Assessment

Transects were surveyed at approximately 50 ft spacing perpendicular to Laguna Shores Road and extended approximately 200 ft past the existing shoreline. The annual high tide line and mean low water Cline were also surveyed. The consultant then determined the definition of the annual high tide line and coordinated with surveyors in the field.

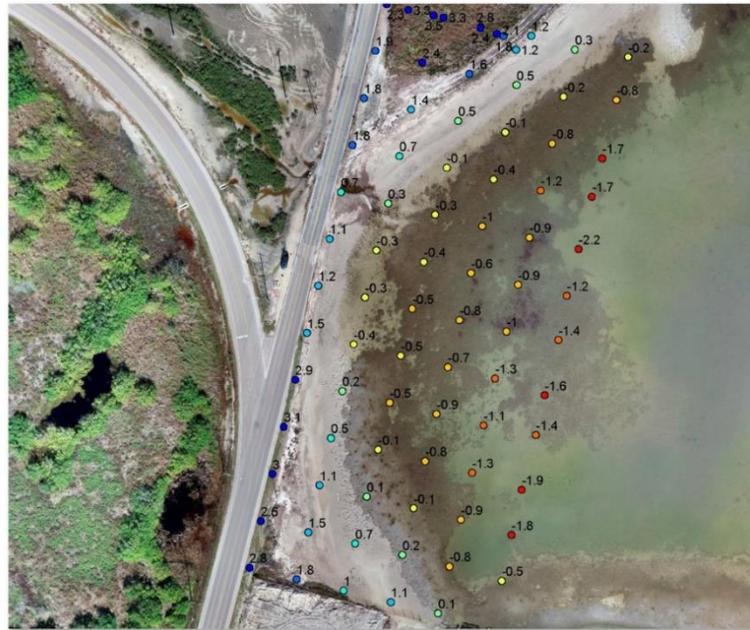
Exhibit 8. Aerial of Locations of Elevation Data Collected

Transects included quadrats to note species present and percent cover. The edge of seagrass was delineated. A biologist was on site to assist TAMU-CC. The estuarine habitat specialists from TAMU-CC and BBEP developed/adapted a standardized monitoring protocol and assessed the existing (baseline) habitat condition within the project area in order to characterize the dominant vegetative community, including elevation regimes for target marsh species.

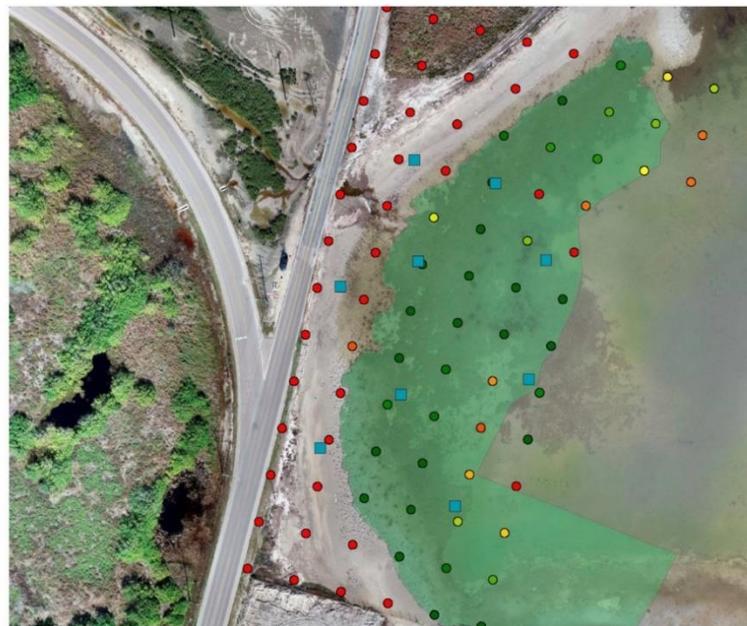
Exhibit 9. Aerial of the Data Collection for Seagrass and Boring Locations

The purpose of the survey was to document the elevations of *Spartina alterniflora* and associated health at sites adjacent to the proposed project location. A surveyor accompanied a biologist to gather elevation data from the bayward edge of the *Spartina* through the landward edge.

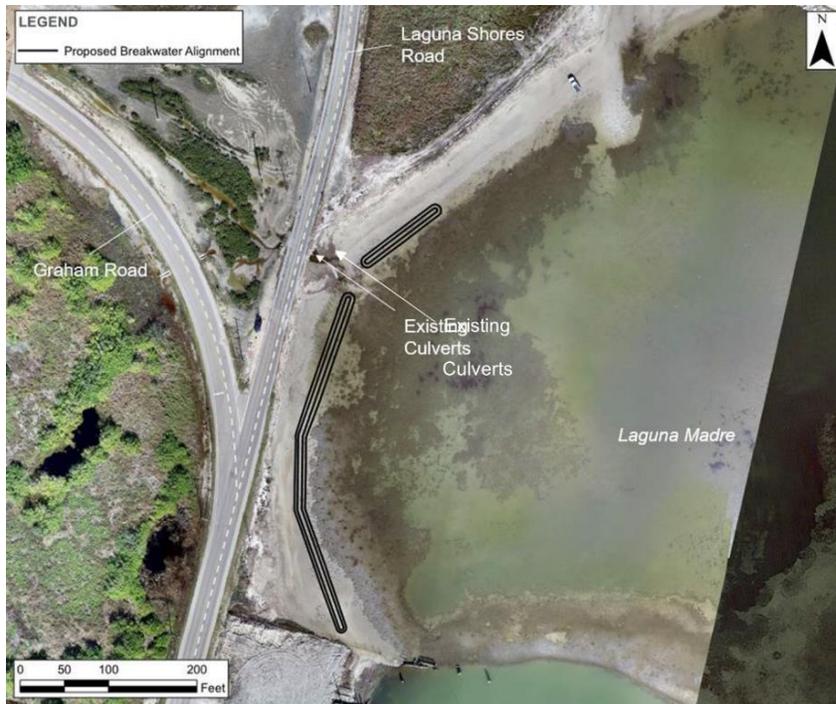
Exhibit 20. Aerial of Proposed Breakwater Alignment

Laguna Shores Road is exposed to open fetches from the southeast. During high tide events, water levels reach the articulated mat currently being used as erosion control on the road slopes. Repeated exposure to wave attack during these high tide events will likely cause scour below the articulated mat and lead to undermining. Waves approaching the shoreline run-up onto the existing roadway and will likely run-up onto the proposed roadway. Lastly, during significant storm events, waves can reach the roadway and areas landward. To address erosion along the existing project shoreline and provide increased protection to the road, two living shoreline protection alternatives were considered. The living shoreline alternatives include a breakwater system and imported fill for marsh planting that provide wave attenuation benefits and increased habitat. The shoreline protection feature alignment was developed to avoid impacts to existing seagrass beds, allow room for marsh fill, and be constructed with land-based equipment rather than water-based equipment such as barges. The proposed breakwater alignment is between the 0.0 ft and +1.0 ft contours. It features a 35 ft gap near the existing culverts under Laguna Shores Road to facilitate drainage and flow through the culverts. The southern breakwater is 400 ft and the northern breakwater is 100 ft for a total length of 500 ft.

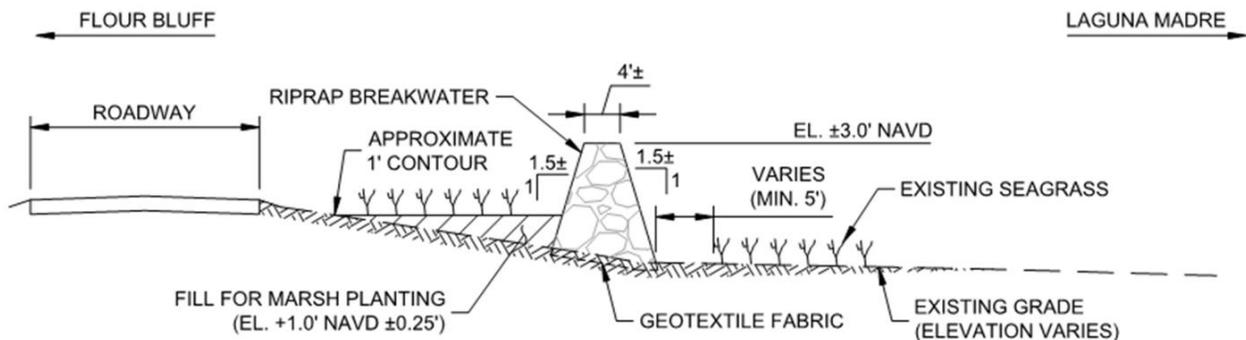
Exhibit 21. Schematic of Typical RipRap Breakwater Section

Riprap breakwaters can significantly reduce the transmitted wave height in both deep and shallow depths and can be used effectively in high or low energy environments. Riprap also provides hard substrate habitat for encrusting species including oysters and barnacles and serves as habitat for juvenile fish, crabs, and other invertebrates. A stone stability analysis using modeled wave conditions was conducted and resulted in a recommended median stone weight (W50) of 150 lbs and a median stone diameter (D50) of 1.0 ft. A design crest elevation of +3.0 ft and crest width of 4.0 ft was selected to reduce the wave energy transmitted through the structure to levels acceptable for vegetation growth. The crest elevation will allow for estimated long-term settlement of up to 6 inches while still providing wave reduction and attenuation in storm conditions. Side slopes of 1.5H:1V were selected to minimize the breakwater footprint and allow for more marsh fill area. A geotextile fabric will be placed under the structure to help limit scour and settling. A riprap breakwater would be constructible using equipment typically on site for roadway construction. Approximately 800 tons of graded riprap will be required to construct the breakwater. Exhibit 21 depicts a typical riprap breakwater section along with the marsh planting area for the Laguna Shores project site.

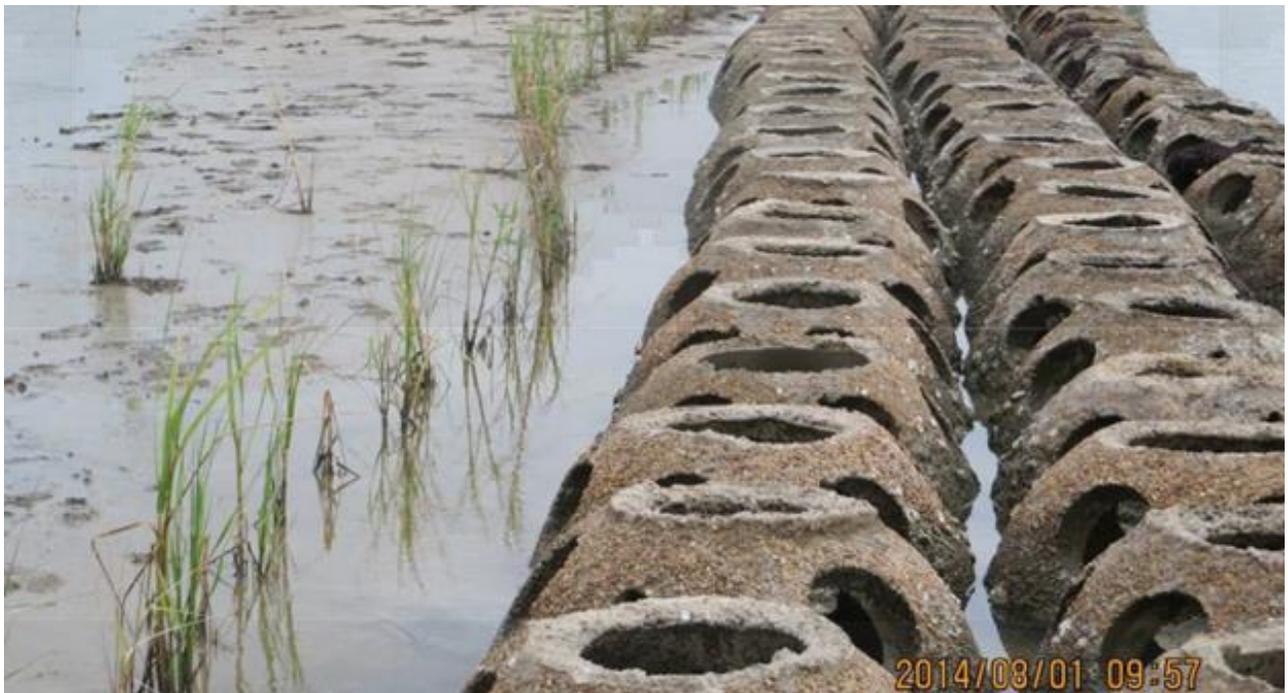
Exhibit 22. Image of Reef Ball Breakwater

Example of a reef ball breakwater in Oyster Lake in West Galveston Bay, TX. Note that the first row of reef balls on the right is leaning forward due to undermining. Photo credit: Consultant.

Reef balls are hollow, hemispherical shaped artificial reef units cast from concrete with randomly placed holes to allow for wave energy dissipation and habitat creation. Reef balls come in a variety of sizes with heights ranging from 1 ft to 5 ft and weights ranging from 45 lbs to 6,000 lbs. Reef balls provide excellent habitat for marine animals, but have varied effectiveness at reducing wave transmission, making them more suited to shallow water, low energy environments. Guidance recommends that reef ball breakwaters consist of at least three rows of units to adequately reduce wave transmission. However, monitoring results at other project sites have shown that the first row of reef balls can be undercut and that 4 rows provides better long-term stability and wave reduction. Considering that the horizontal area available for a breakwater feature at the Laguna Shores site is limited due to the close proximity of seagrass adjacent to the roadway, multiple rows of reef balls may not be feasible and could also reduce the area available for marsh fill and planting. Reef balls also have more stability and habitat value with lower crest elevations, which reduces the wave attenuation properties as more wave energy passes over the semi-submerged breakwaters when compared to higher elevation structures. Lastly, the bottom elevations along the proposed breakwater alignment are variable, which would result in variation of breakwater height due to consistent elevations of the reef ball units. Graded riprap breakwaters are better suited to variable bottom depths and can more readily achieve a consistent crest elevation. The reef balls would be placed on a geotextile fabric and/or geogrid.

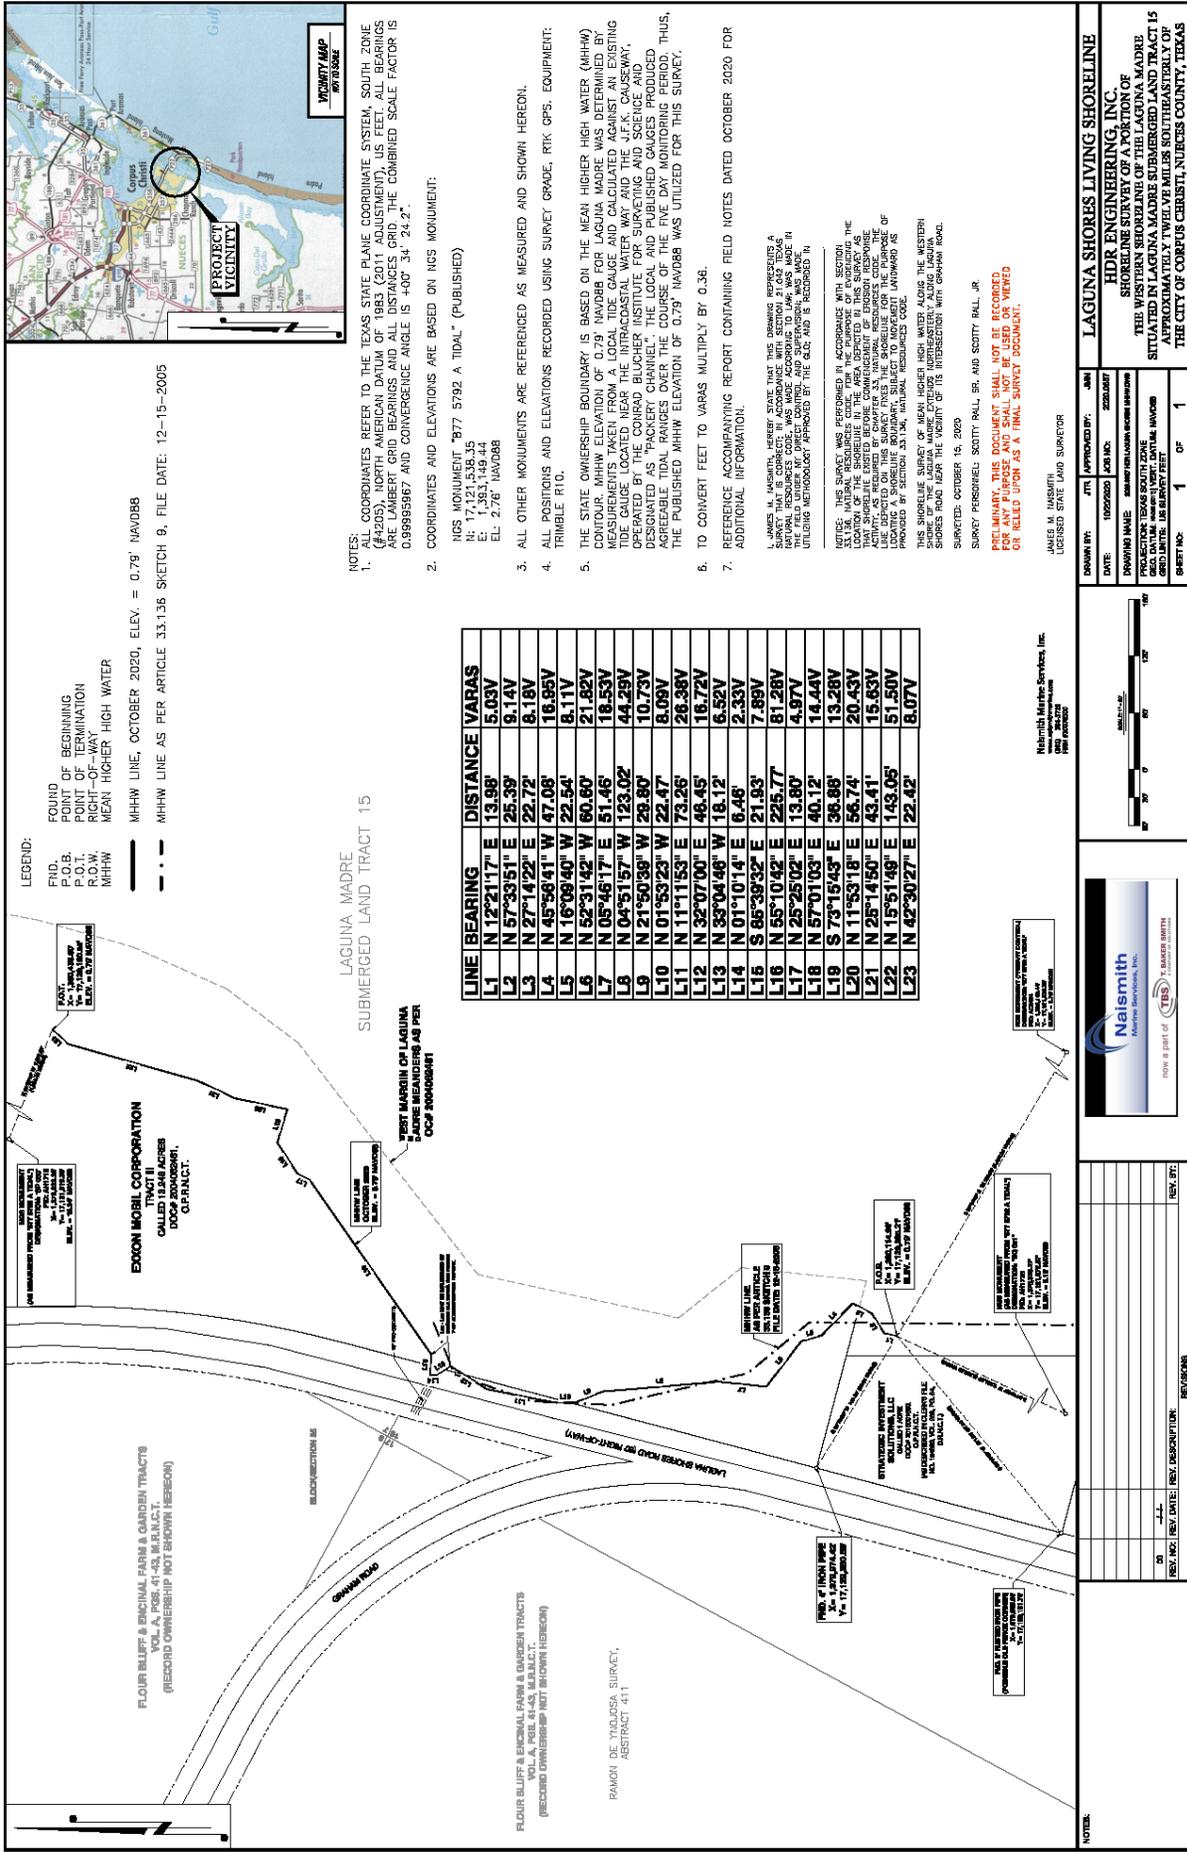
Exhibit 25. Plan of the Required Boundary Survey for Submerged Parcel per GLO Requirements

MHHW LINE, OCTOBER 2020, ELEV. = 0.79 NAVD88
 MHHW LINE AS PER ARTICLE 33.136 SKETCH 9, FILE DATE: 12-15-2005

8. MHHW ELEVATION OF 0.79' NAVD88 FOR LAGUNA MADRE WAS DETERMINED BY MEASUREMENTS TAKEN FROM A LOCAL TIDE GAUGE AND CALCULATED AGAINST AN EXISTING TIDE GAUGE LOCATED NEAR THE INTRACASTAL WATER WAY AND THE U.F.K. CAUSEWAY, OPERATED BY THE CONRAD BLOCHER INSTITUTE FOR SURVEYING AND SCIENCE AND TECHNOLOGY.

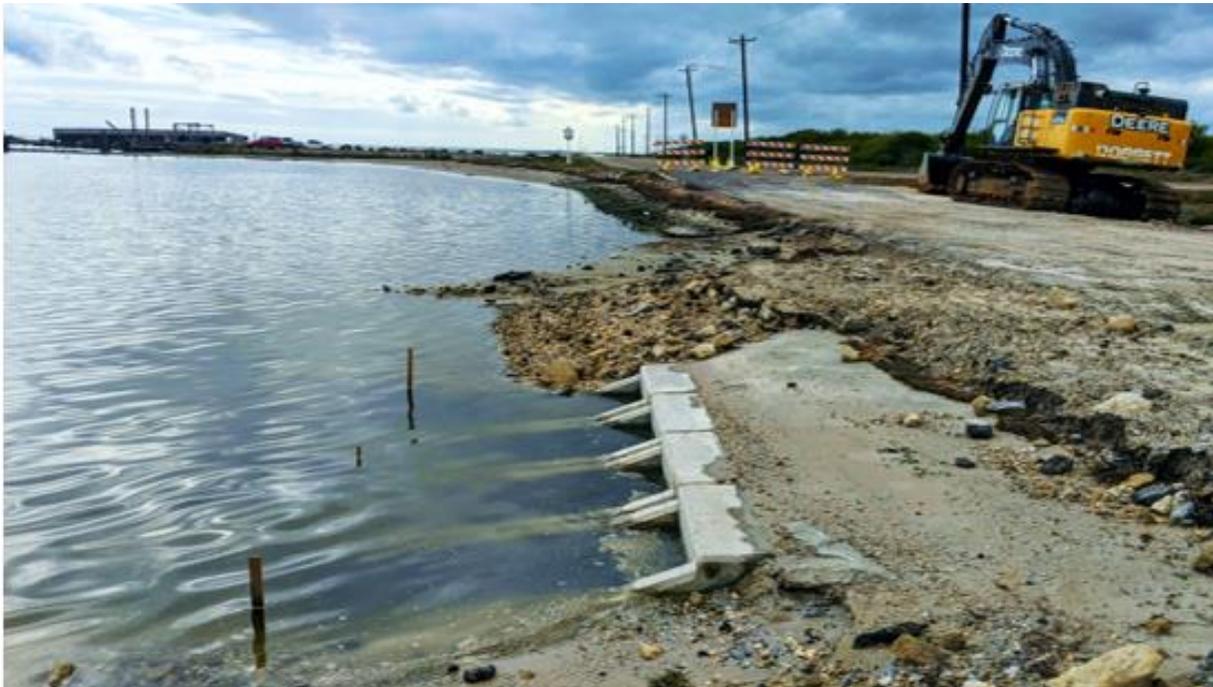
Exhibit 26. Construction at Laguna Shores Road in the Vicinity of the Future Breakwater

This photo shows the new drainage element in the vicinity of the Laguna Shores Road future breakwater. Photo credit: Corpus Christi MPO.

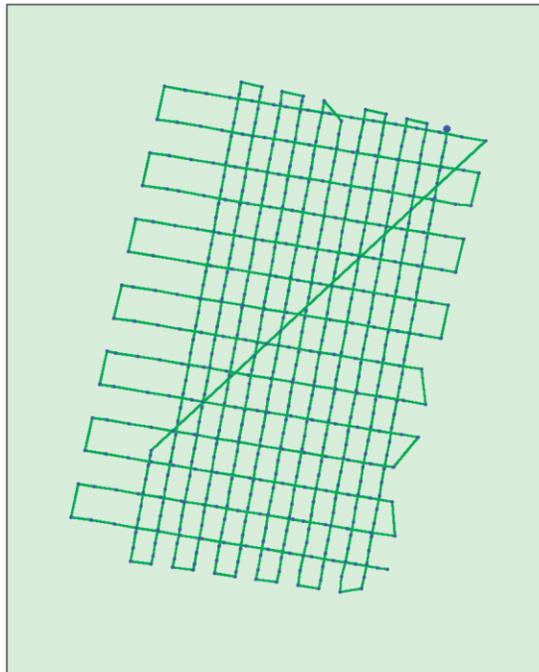
Figure 2: Top view of the initial image position. The green line follows the position of the images in time starting from the large blue dot.

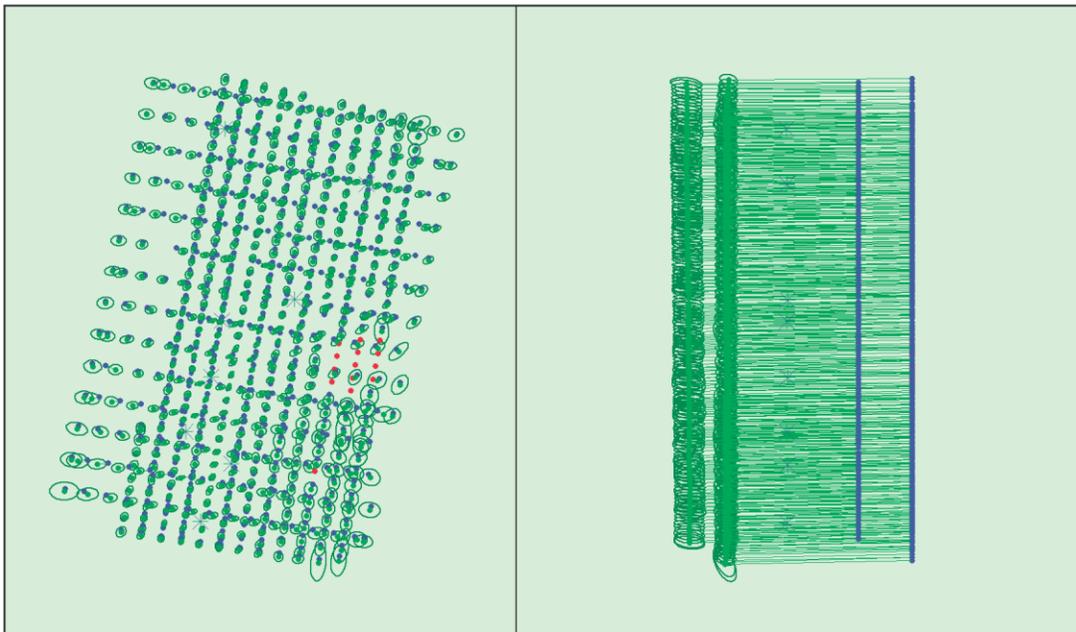
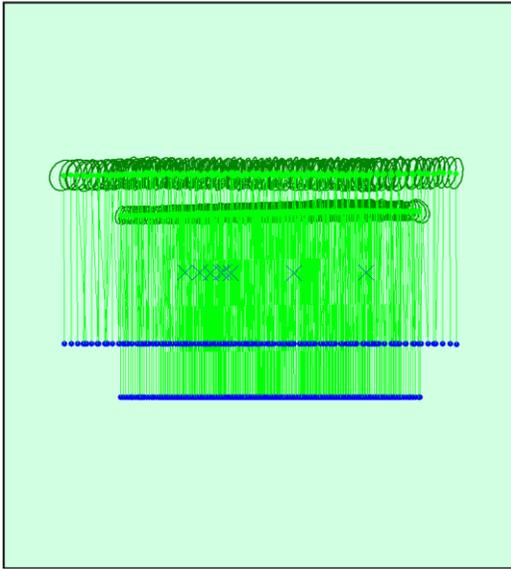
Figure 3: Offset between initial (blue dots) and computed (green dots) image positions as well as the offset between the GCPs initial positions (blue crosses) and their computed positions (green crosses) in the top-view (XY plane), front-view (XZ plane), and side-view (YZ plane). Red dots indicate disabled or uncalibrated images. Dark green ellipses indicate the absolute position uncertainty of the bundle block adjustment result.

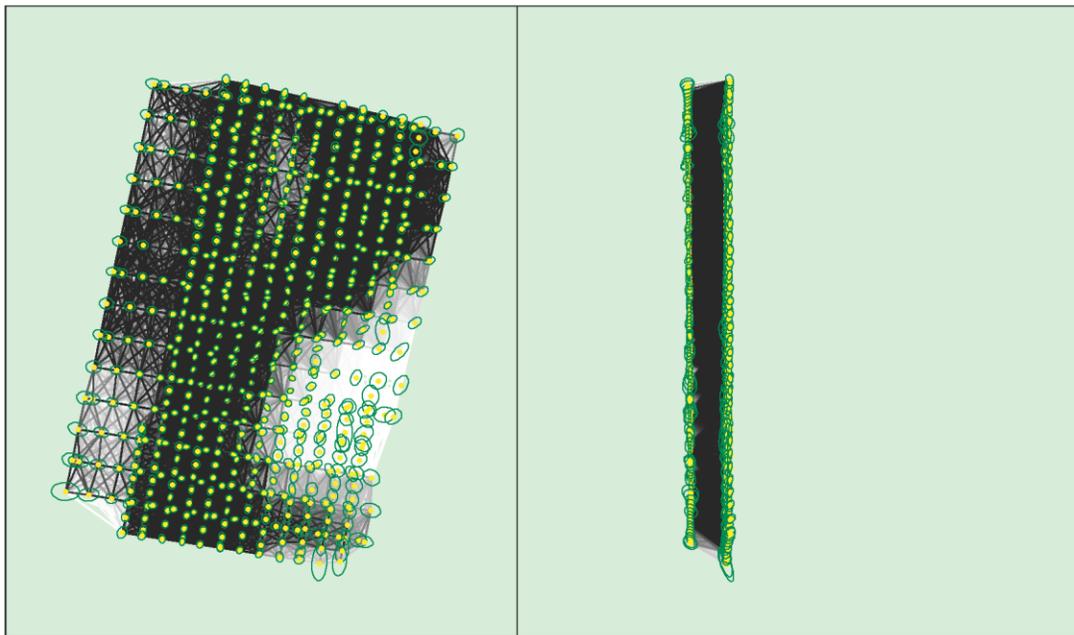
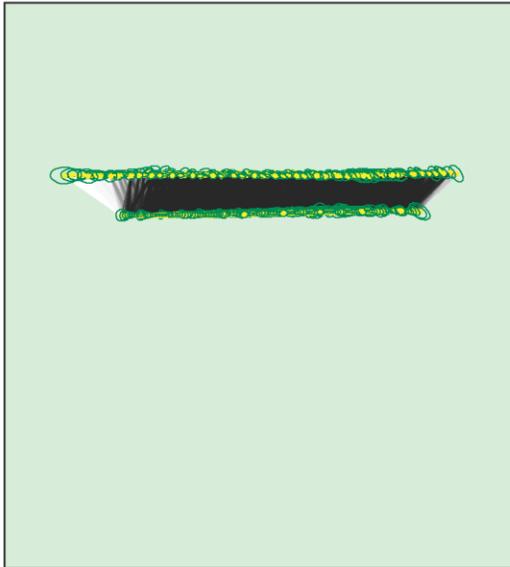
2 2D Keypoint Matches

Figure 5: Computed image positions with links between matched images. The darkness of the links indicates the number of matched 2D keypoints between the images. Bright links indicate weak links and require manual tie points or more images. Dark green ellipses indicate the relative camera position uncertainty of the bundle block adjustment result.

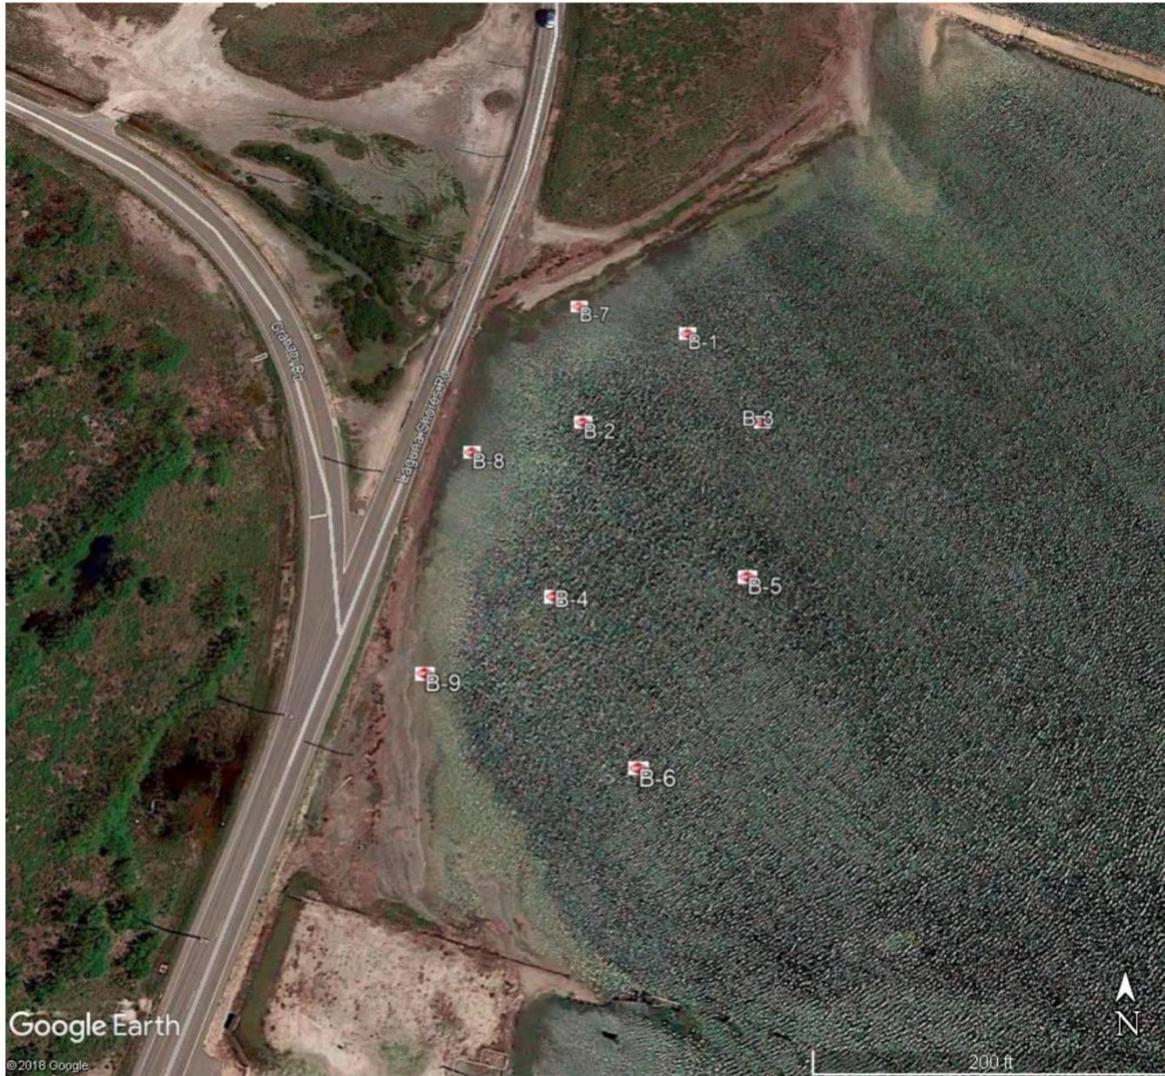
BORING LOCATION PLAN

LAGUNA MADRE BREAKWATER PROJECT
 Laguna Shores Road and Graham Road
 Corpus Christi, Texas
